MANDATORY SERVICE BULLETIN

DATE: December 1, 1997
Service Bulletin No. 406A
(Supersedes Service Bulletin No. 406)
Engineering Aspects are
FAA Approved

SUBJECT: Titan Fuel Pump Inspection

MODELS AFFECTED: All Textron Lycoming engines equipped with Titan AN type gear driven fuel pumps.

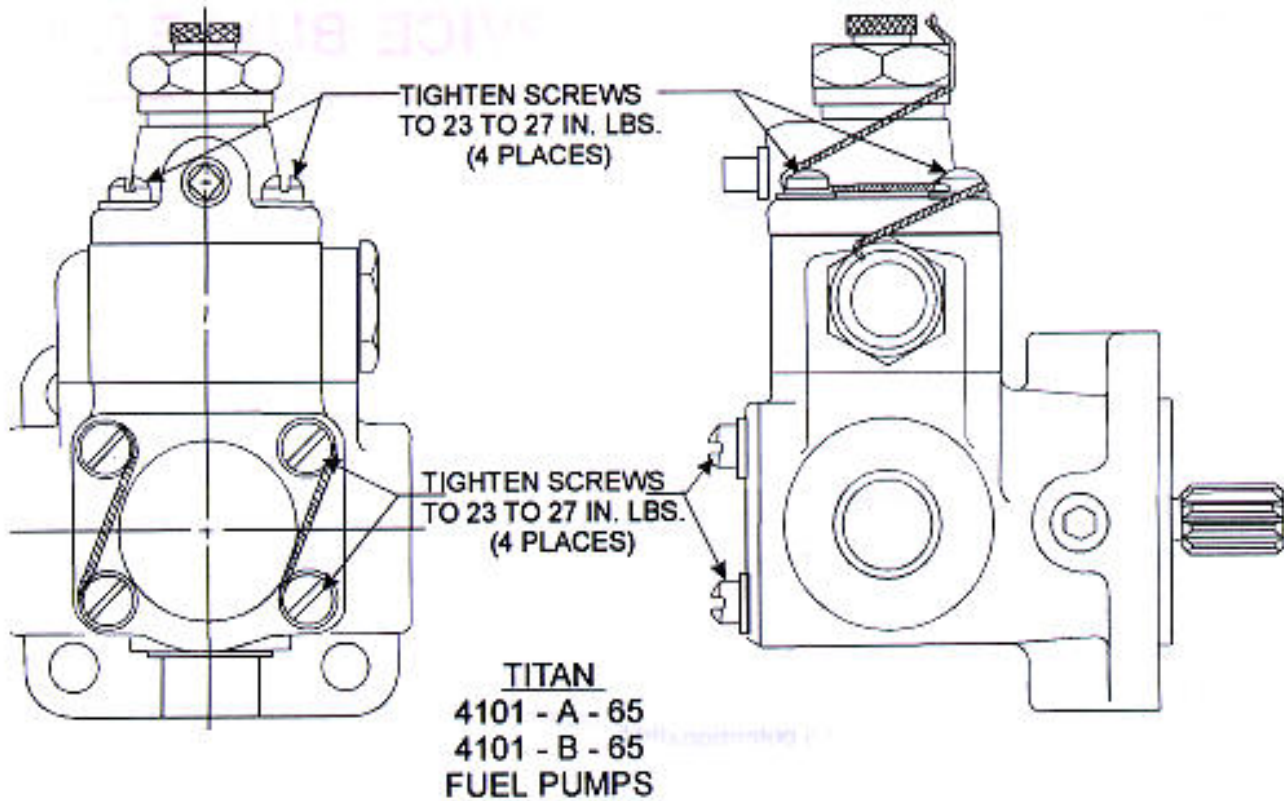
Insufficiently tightened cover attaching screws on AN type fuel pumps can be a source of fuel leakage. This condition may occur on new installations due to gasket material taking a set.

Titan Fuel Pumps Showing Applicable Attaching Screws and Orientation of Lockwire

1. With a screwdriver, check every screw that is used to assemble the pump. Determine if any are loose, that is if any can be turned within the limits of the lockwire in a clockwise direction, and within the limits of the torque value specified below.
2. If any screw appears to be loose, remove the lockwire and retighten evenly all four attaching screws to the torque value specified.
3. Secure the screws with lockwire as shown in the illustration.
4. Note compliance with this Bulletin in the aircraft records.

Titan Pumps. 23 to 27 inch pounds
