# MANDATORY SERVICE BULLETIN

Service Bulletin No. 439A  
(Supersedes Service Bulletin No. 439)  
Engineering Aspects are  
FAA Approved

**SUBJECT:** Inspection of Connecting Rods for Fretting and/or Galling and Repair of Fretting.

**MODELS AFFECTED:** All Textron Lycoming aircraft engines.

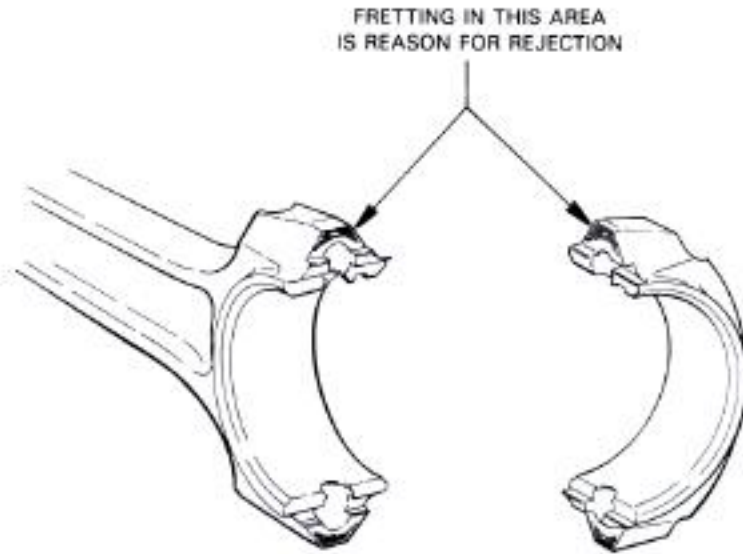
Figure 1. Connecting Rod and Cap Showing Damage by Fretting

Fretting occurs between the connecting rod parting face and cap face due to motion between the mating surfaces. See Figure 1. If this condition exists, the connecting rod must be scrapped. During manufacturing, the contact faces of the rod and cap are ground very precisely. Fretting on this surface can induce bending in the bolt which could result in failure of the bolt and/or the connecting rod.

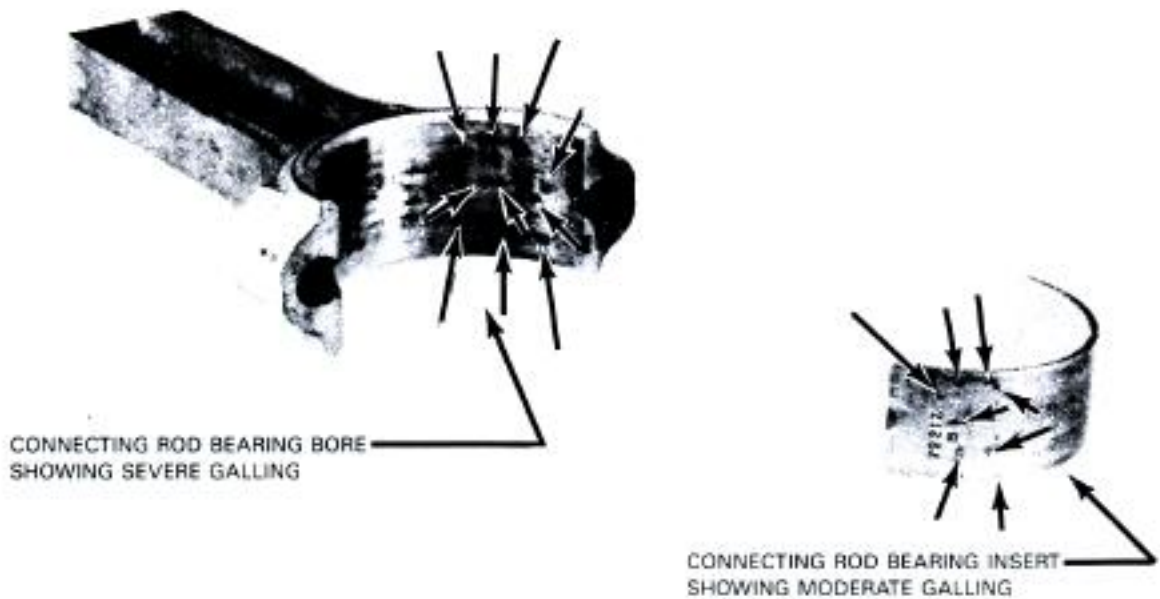
Figure 2. Bearing Insert and Connecting Rod Showing Damage by Galling

Galling, as shown in Figure 2, is caused by a movement between the surfaces of the bearing insert and the connecting rod during periods of high loading such as is produced during overspeed or excessive manifold pressure operation. The visual evidence produced by galling appears as if particles of metal from one contacting surface had welded to the other. The bearing

insert shown in Figure 2 represents a typical case of galling; while the connecting rod bearing bore shown is an example of severe galling and indicative of imminent failure of the connecting rod.

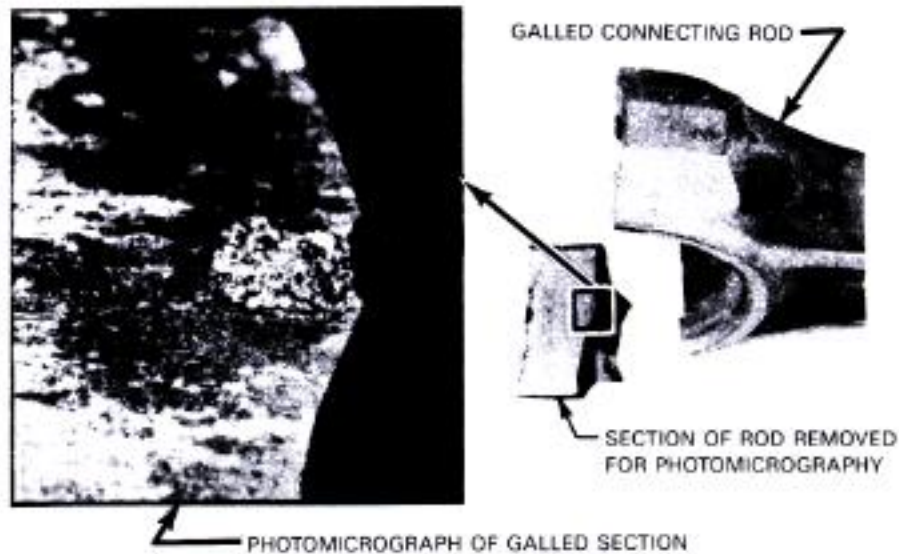
Figure 3. Photo-Micrograph of Gall Mark on Connecting Rod Surface

The seriousness of galling is illustrated in Figure 3. This picture was made from an unretouched photomicrograph of an unetched section of metal removed from a cracked connecting rod. The gall mark that caused the crack can be seen on the magnified view of the bearing surface.

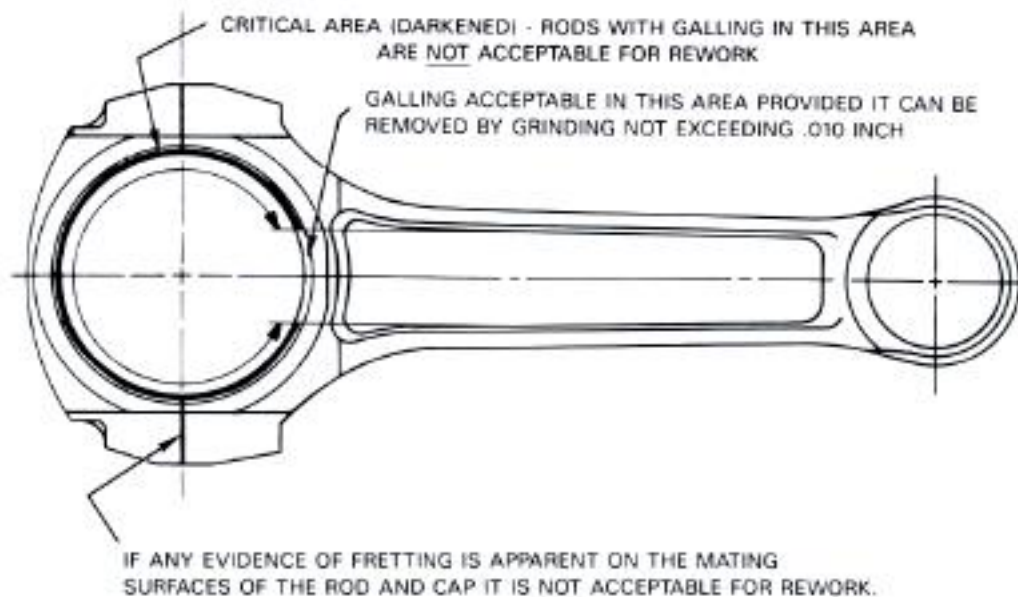
Figure 4. Diagram of Connecting Rod Showing Area of Critical Galling

It has been found that the location of galling determines if the rod is or is not likely to fail. Galling marks in the bearing bore are critical except for the area directly under the

I-beam of the rod. Do not scrap a rod because of galling that is confined to this area; but also do not reuse a rod having gall marks in the critical area as shown in Figure 4.

1. Check connecting rod by magnetic particle method to determine if rod is suitable for reuse. (See latest edition of S.I. 1285.) If magnetic particle check indicates rod is cracked, do not reuse. If rod bore is worn or galling is evident as shown in Figure 4; and upon inspection it is found to be reworkable, it may be reworked by grinding the crankpin bore of the rod .010 inch oversize. Product improvements have made certain con-
