MANDATORY SERVICE BULLETIN

DATE: May 2, 1995
Service Bulletin No. 518C
(Supersedes Service Bulletin No. 518B)
Engineering Aspects are
FAA Approved

SUBJECT: Inspection of Thermostatic Bypass Valves

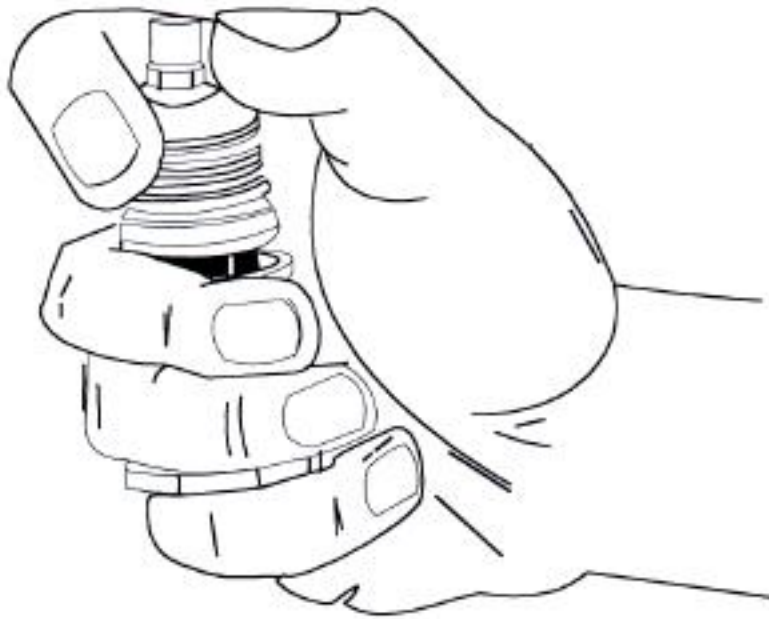
Figure 1.

Textron Lycoming has received reports that a number of thermostatic bypass valves are in service with loose crimp nuts. It has been shown that the nut can work free and drop into the engine causing engine damage.

A physical inspection of the crimp nut is required to ensure it is seated and solid on the shaft. Separate the seat and retaining nut by holding the valve assembly in one hand and compressing the valve spring with the forefinger and thumb. (See Figure 1.) With the seat and nut separated, grasp the crimp nut with the other hand and attempt to move it. The crimp nut must not move. If the thermostatic bypass valve assembly does not meet this inspection, it must be reworked or replaced immediately.

Rework of the thermostatic bypass valve can be accomplished by following the procedure in Service Instruction No. 1423. Although Service Instruction No. 1423 refers only to P/N 75944 thermostatic bypass valves, for the purpose of this rework it applies to all thermostatic bypass valves specified above.

After rework, the thermostatic bypass valve must be reinspected annually until replacement.
