MANDATORY SERVICE BULLETIN

Service Bulletin No. 525A
(Supersedes Service Bulletin No. 525)
Engineering Aspects are
FAA Approved

SUBJECT: Inspection of High Pressure Fuel Pump P/N LW-15473

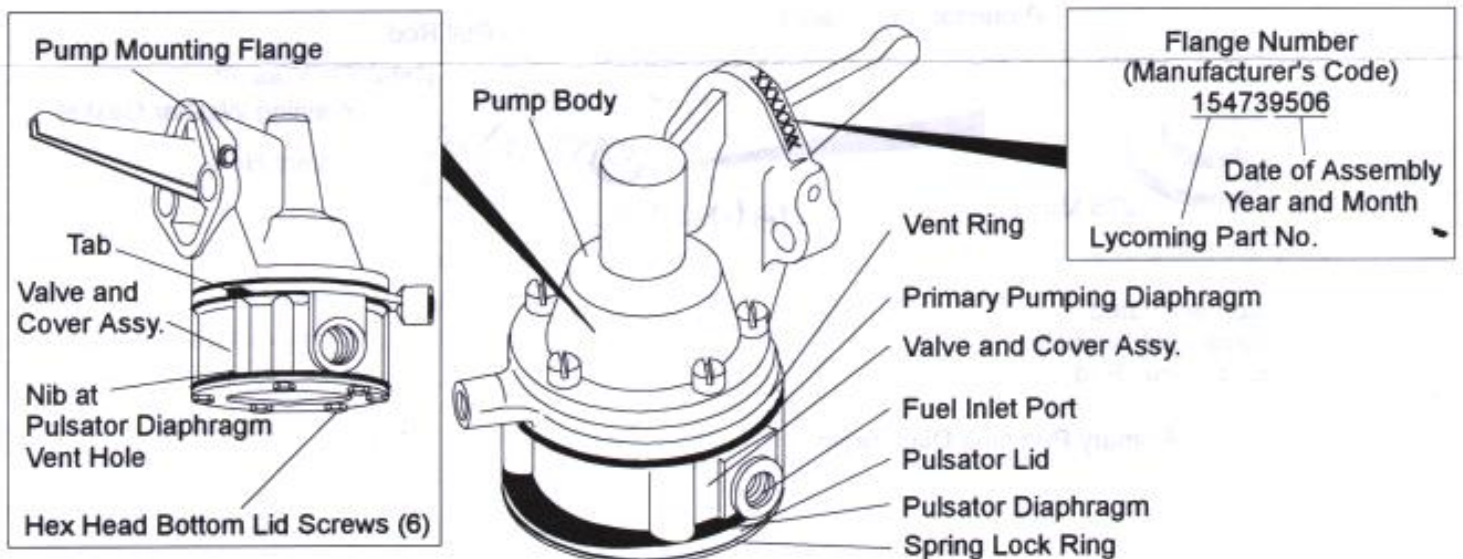
Figure 1.

If your Textron Lycoming engine has a P/N LW-15473 high pressure fuel pump installed, with flange number (manufacturer's code) scribed on the pump of 154739506, 154739507 or 154739510, it must be inspected before further flight of your aircraft.

3. Completely loosen but do not remove the six hex head bottom lid screws and remove the entire bottom section of the pump as a unit assembly including the lid screws and valve and cover assembly. (Refer to Figure 1 and 4.) Set this unit assembly aside for later examination (step 7). Note, this unit may be further disassembled for cleaning.

11. To identify that this examination was accomplished on the pump assembly, mark an "A" by metal stamp or scribe on the pump mounting flange immediately before the flange number (manufacturer's code). (Refer to Figure 1). If necessary due to space constraints, the "A" may be located just above the rocker shaft pin. An entry in the engine and/or aircraft log book should also be made.

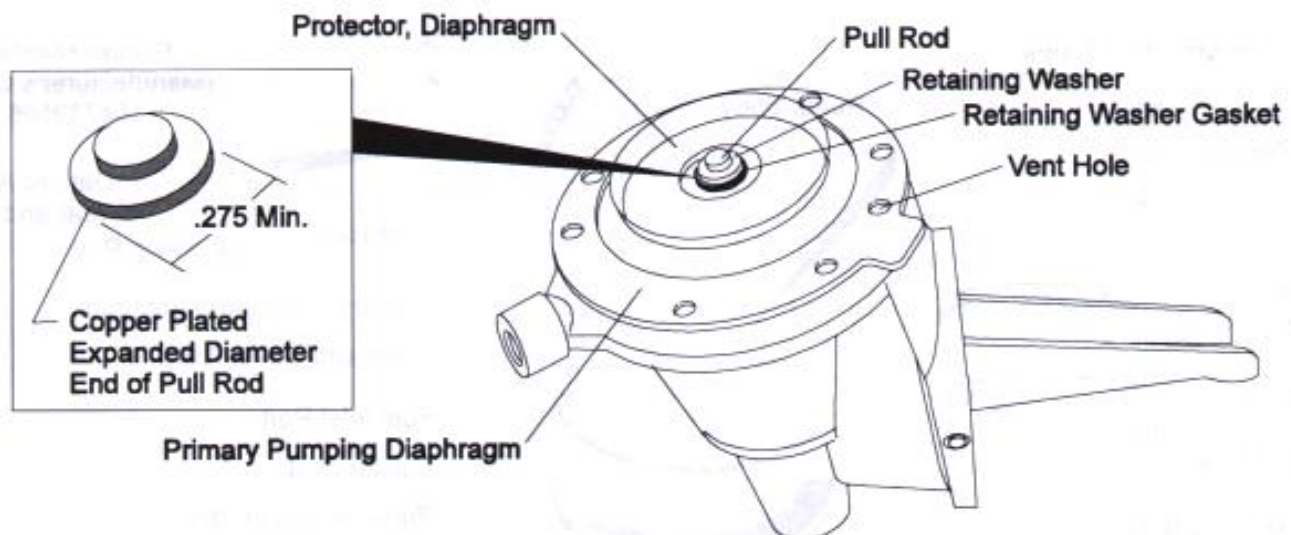
Figure 2.

Textron Lycoming has determined that a number of high pressure fuel pumps, P/N LW-15473, manufactured between June and October of 1995 may have manufacturing defects that may result in engine stoppage. Several instances have occurred where the retaining washer gasket has separated from the pull rod assembly and lodged in the pump outlet valve restricting fuel flow.

4. Visually inspect for proper location and retention of the retaining washer gasket in the pull rod/diaphragm assembly. (Refer to Figure 2.) If the gasket is not found between the retaining washer and diaphragm protector or it protrudes more than 1/16 inch beyond the retaining washer at any point, the pump is unserviceable and must be replaced.

5. Using vernier or dial calipers, measure the diameter of the larger copper plated expanded end of the pull rod immediately next to the retaining washer (see Figure 2). If this diameter measures less than .275 inches, the pump is unserviceable and must be replaced.

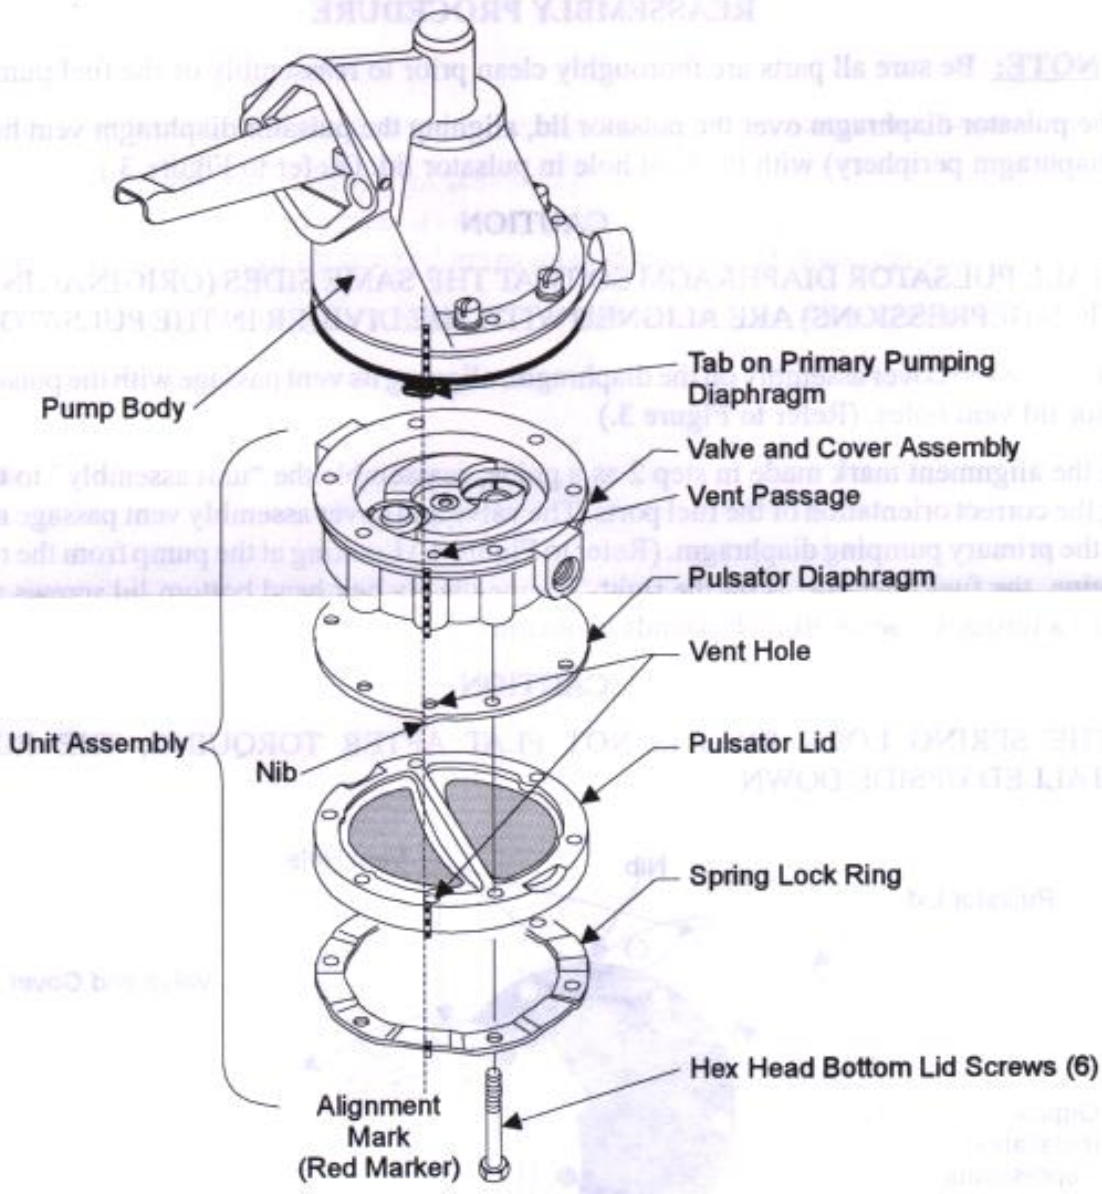
Figure 4.

7. Examine the pulsator diaphragm from the unit assembly set aside in step 3, (Refer to Figure 4) as follows:

10. Using the alignment mark made in step 2 as a guide, reassemble the "unit assembly" to the pump body observing the correct orientation of the fuel ports. The valve and cover assembly vent passage must align with the tab on the primary pumping diaphragm. (Refer to Figure 4.) Looking at the pump from the rear as installed on the engine, the fuel inlet port is on the right. Torque the six hex head bottom lid screws alternately and evenly until a torque value of 30 inch pounds is obtained.

When reinstalling the spring lock ring on the bottom of the pump, ensure that the bolt head is against the high segments of the ring.

IF THE SPRING LOCK RING IS NOT FLAT AFTER TORQUING, THE RING IS INSTALLED UPSIDE DOWN.
