SERVICE BULLETIN

Service Bulletin No. 529B
(Supersedes Service Bulletin No. 529A)
Engineering Aspects are
FAA Approved

SUBJECT: Reprint of Crane/Lear Romec Service Bulletin No. 101SB020, Rev. 3

FUEL PUMP – Torquing of Relief Valve Cover Screws.

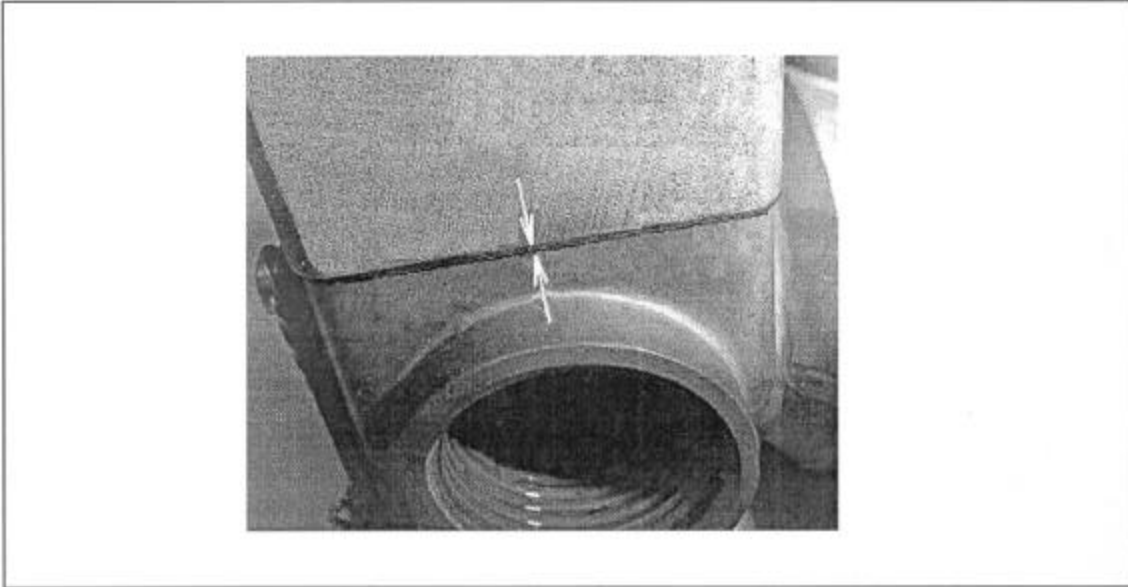
Normal Extrusion – All Series
Figure 3
