# SERVICE BULLETIN

DATE: July 1, 2003 Service Bulletin No. 543B  
(Supersedes Service Bulletin No. 543A and  
Supplement No. 1 to Service Bulletin No. 543A)

SUBJECT: Oil Filter Converter Plate Gasket Replacement

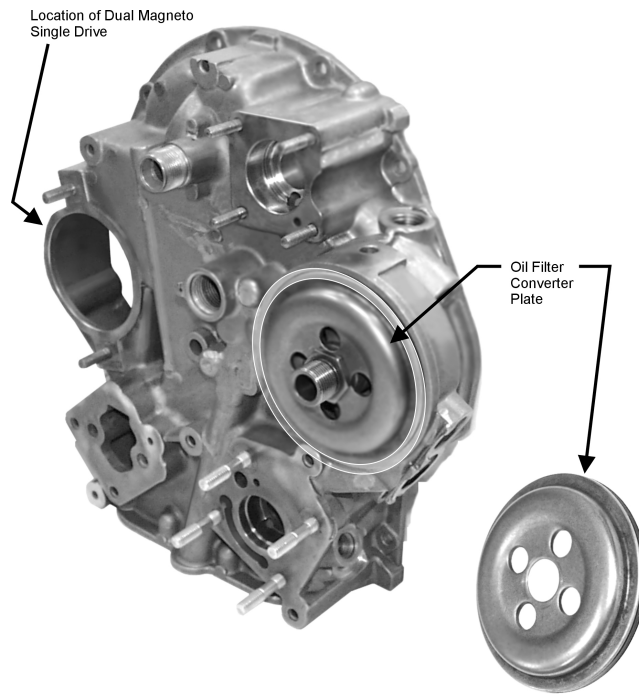
Figure 1.

Lycoming has determined that some P/N LW-13388 oil filter converter plate gaskets were made from incorrect material. This could cause some converter plate gaskets to become extruded from the seat, allowing oil to leak out between the plate and the accessory housing.

1. Remove the oil filter and the converter plate (Figure 1). Remove the gasket from the plate in accordance with the latest revision of Lycoming Service Instruction No. 1453.
