Airworthiness Directive

Amendment 39-4658; AD **82-20-01**

Airworthiness Directives; BENDIX: Applies to Bendix Engine Products Division Magnetos
PDF Copy (If Available):

82-20-01 BENDIX: Amendment 39-4658. Applies to Bendix Engine Products Division magnetos with type designations listed below:

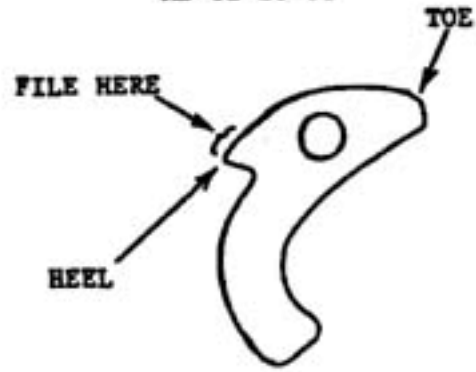
FIGURE 1

To prevent failure of impulse coupling due to improperly heat treated (soft) flyweights resulting in engine damage or failure, accomplish the following: (Ref. Bendix Service Bulletin No. 623 dated September 1982.)

3. Use finger pressure to push inward on the toe (see Figure 1) of each flyweight so that the flyweight heel protrudes outward.
4. Using a fine #1, double cut, 1/2-inch wide file at least 3/32-inch thick, pass the file across the heel of the flyweight attempting to remove material (see Figure 1). If the flyweight has been properly heat treated, the file will "glide" smoothly over the heel of the flyweight, removing no material. If the flyweight is not properly heat treated (soft), the file will not "glide" easily across the surface of the flyweight heel, and material will be removed.

5. If an improperly heat treated (soft) flyweight is found, immediately remove and replace the cam assembly and/or the impulse coupling assembly with an assembly meeting the requirements of this AD, following procedures in the magneto overhaul instructions, and paying strict attention to notes and cautions.
