HARTZELL PROPELLER INC.  
**SERVICE BULLETIN**

HC-SB-61-227

**Propeller - Hub Inspection**

September 28, 2006

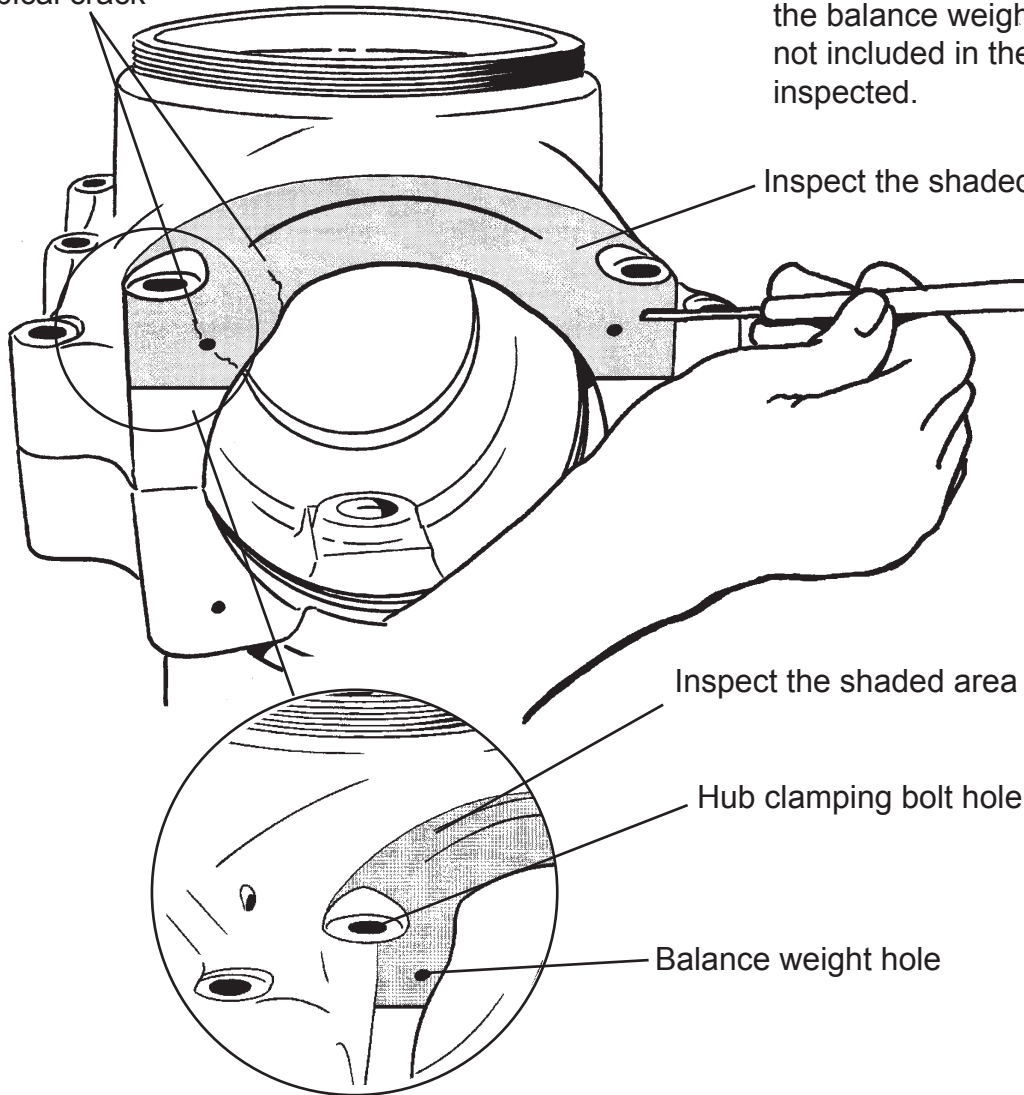
**Socket Fillet Radius Inspection**  
**Figure 3**

- (1) There have been numerous occurrences of hub fillet radius cracks, including incidents of in-flight blade separation in Hartzell two blade "compact" series aluminum hub propellers. Cracks were typically discovered during an inspection following reports of abnormal vibration or grease leakage. Cracks typically initiate in the same region of the hub in the area adjacent to the blade called the "fillet radius". As the cracks propagate toward the center of the hub, their progression accelerates and may result in the failure of one hub half that can progress to blade separation.

Typical crack

NOTE: The hub clamping bolt holes and the balance weight holes are not included in the areas to be inspected.

Circled areas encompass the "fillet radius", must be inspected.

Hubs with no "A" or "B" serial number suffix, and hubs listed in Table 1: Inspect highlighted area on each blade socket (forward hub half) during on-wing inspection, and four points (both hub halves) during overhaul inspection.

- (g) Perform eddy current inspection in accordance with procedures in Hartzell Standard Practices Manual 202A. See Figure 3.

- (5) If a crack indication is found, hub replacement is required before further flight. Report any findings of a cracked hub to the Hartzell Product Support Department.
- (6) If no crack indications are found,
- (a) After the first inspection only, permanently identify the hub to indicate compliance with this Service Bulletin. Use a metal impression stamp (0.125 inch [3.175 mm]), round bottom characters) to stamp the letter E at the end of the propeller serial number. For example, propeller serial number DN1234 would be changed to DN1234E. This change is to be noted in the propeller logbook so that it provides further indication that this Service Bulletin is applicable.
