HARTZELL PROPELLER INC.  
**SERVICE BULLETIN**

**HC-SB-61-269**

**Propeller - Hub Inspection**

September 28, 2006

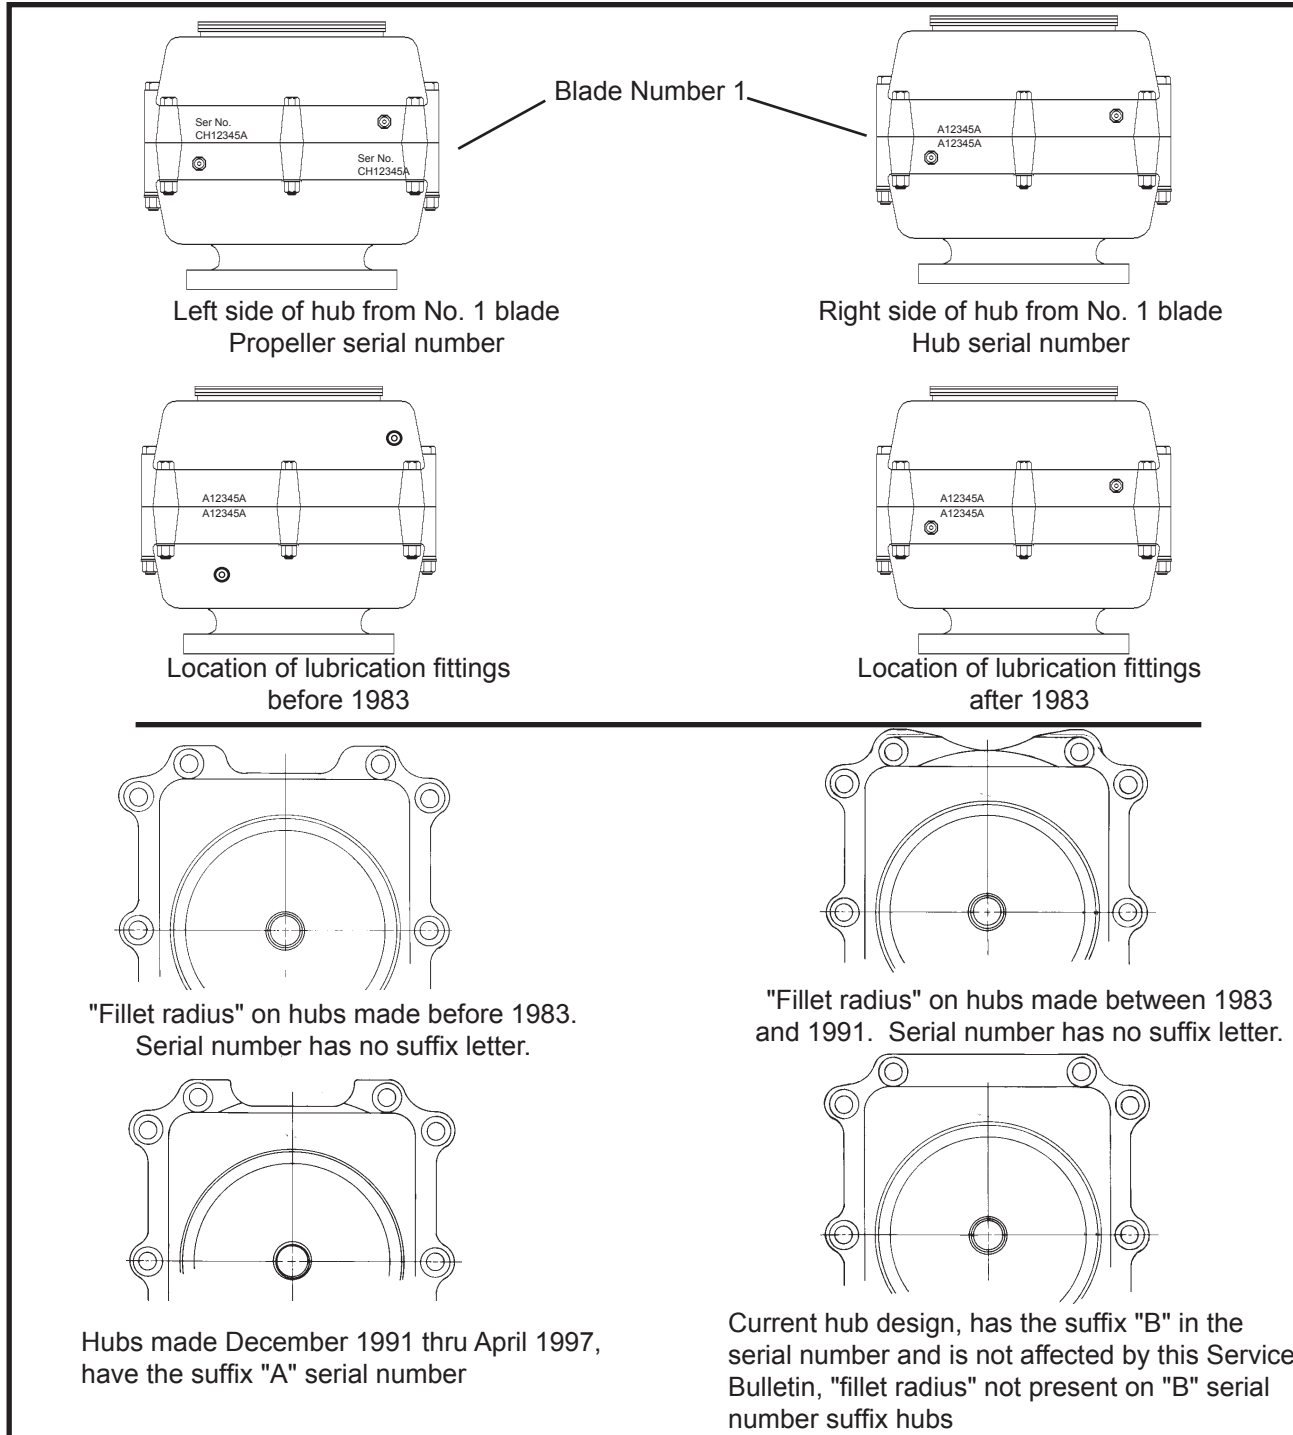
**Hub Identification**  
**Figure 2**

NOTE 2: Hub and propeller serial numbers without suffix letter "A" or "B" were manufactured before 1991 and can be identified by two different styles of the fillet radius as shown in Figure 2. The "E" suffix letter is added to the hub with no suffix serial number to indicate that the initial eddy current inspection has been performed in accordance with this Service Bulletin and a repetitive eddy current inspection is required.

"Fillet radius" on hubs made before 1983.  
Serial number has no suffix letter.

"Fillet radius" on hubs made between 1983  
and 1991. Serial number has no suffix letter.

Hubs made December 1991 thru April 1997,  
have the suffix "A" serial number

Current hub design, has the suffix "B" in the  
serial number and is not affected by this Service  
Bulletin, "fillet radius" not present on "B" serial  
number suffix hubs
